Delayed Fracture of a PFM Nit-Occlud Flex Coil after Transcatheter Occlusion of Patent Ductus Arteriosus

We report the fracture of a 4×4 Nit-Occlud pfm coil in a child with patent ductus arteriosus (PDA), bicuspid aortic valve, and coarctation, detected three years after deployment without any adverse consequent. This report emphasizes the importance of adherence to the user guidelines of the company for the implementation of the device and also shows the significance of lateral chest X-ray in the follow-up of patients after the occlusion of the PDA, particularly in the case of using smaller-sized, frail pfm coils for the detection of coil fracture (*Iranian Heart Journal 2011; 12 (1):56 -59*).

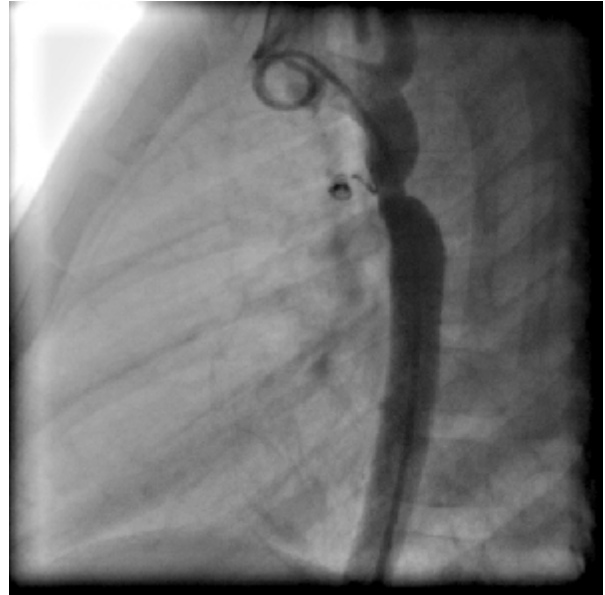
Fig. 1. A: Plain AP CXR shows fracture of coil on careful inspection; B: on AP view at cineangiography the fracture is unremarkable.

The fracture was simply overlooked on the usually-obtained anteroposterior chest X-rays for follow-up and on routine follow-up 2D echocardiography. Even the anteroposterior fluoroscopic image failed to show it (Fig. 2).

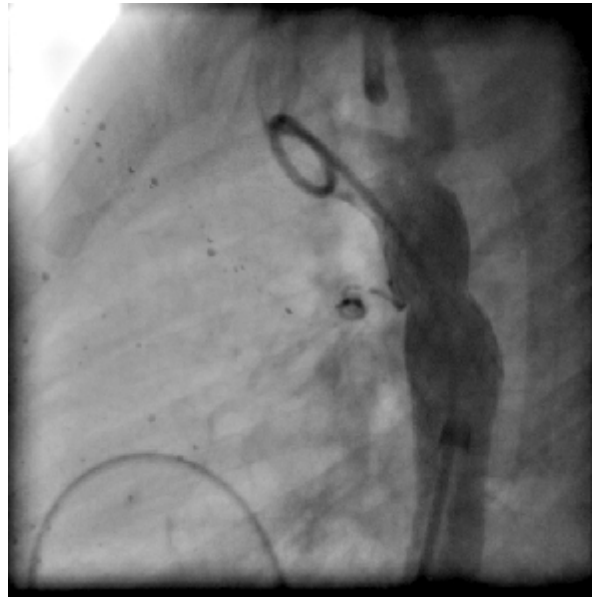
However, the lateral view clearly revealed the broken coil (Fig. 3). The patient underwent a successful coarctation stenting using a 29-mm Palmaz Genesis XD (Abbott Laboratories, USA) mounted on a BIB of 14 mm× 40mm. After the procedure, the pressure gradient across the coarctation abolished completely (Fig. 4).

Fig. 3. Lateral descending aortogram after 29-mm Genesis XD stent implantation
